CONVERSION AND ADAPTATION

Assignment 2: Individual Conversion and Adaptation Report

A report based on an existing building to determine the feasibility of a proposed conversion and refurbishment for ground floor commercial units with residential apartments to 1st, 2nd, and 3rd floors. Feasibility is based on a desktop survey & onsite photograph's. All defects are accessed including their severity and any remedial measures that may be required. Two of these defects are studied in further detail including detailed drawings of required remedial works and any relevant restrictions or stipulations.

Paul McVeigh – B00731447

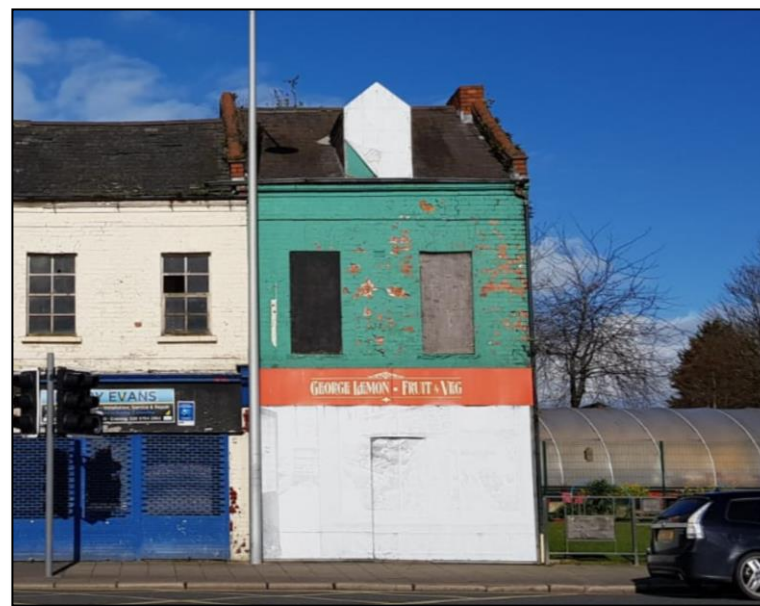
Figure 4 - Photo of existing building

This building is not as quite as old and is not an actual listed building. It is still very important to honour and respect the architectural history and culture of the surrounding area. The original red brickwork can be seen below the peeling paint. Any restoration work should try to restore this and retain the character of the area.

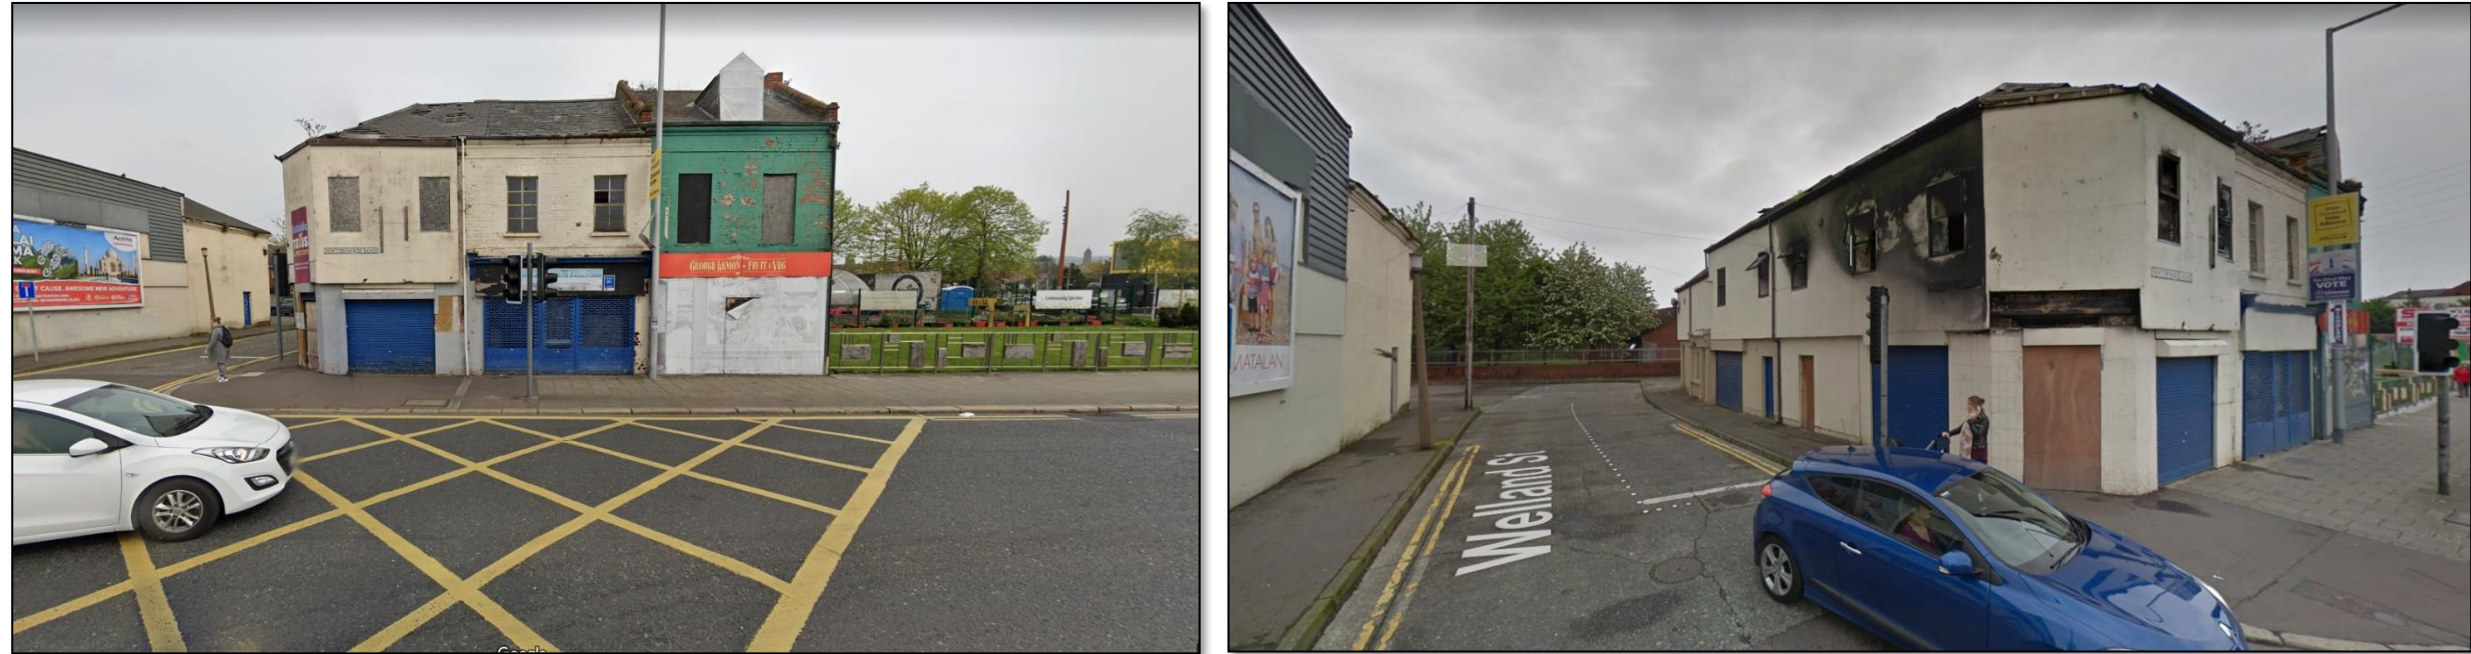
Figure 7 - Google Maps photos of building (GoogleMaps, 2020)

The building has 3 ground floor retail units, a garage and one upper floor apartment. It's been vacant for at least 15 years and has been left unmaintained. Fire damage to the property can be clearly seen in the Google Maps Photos (May2014).

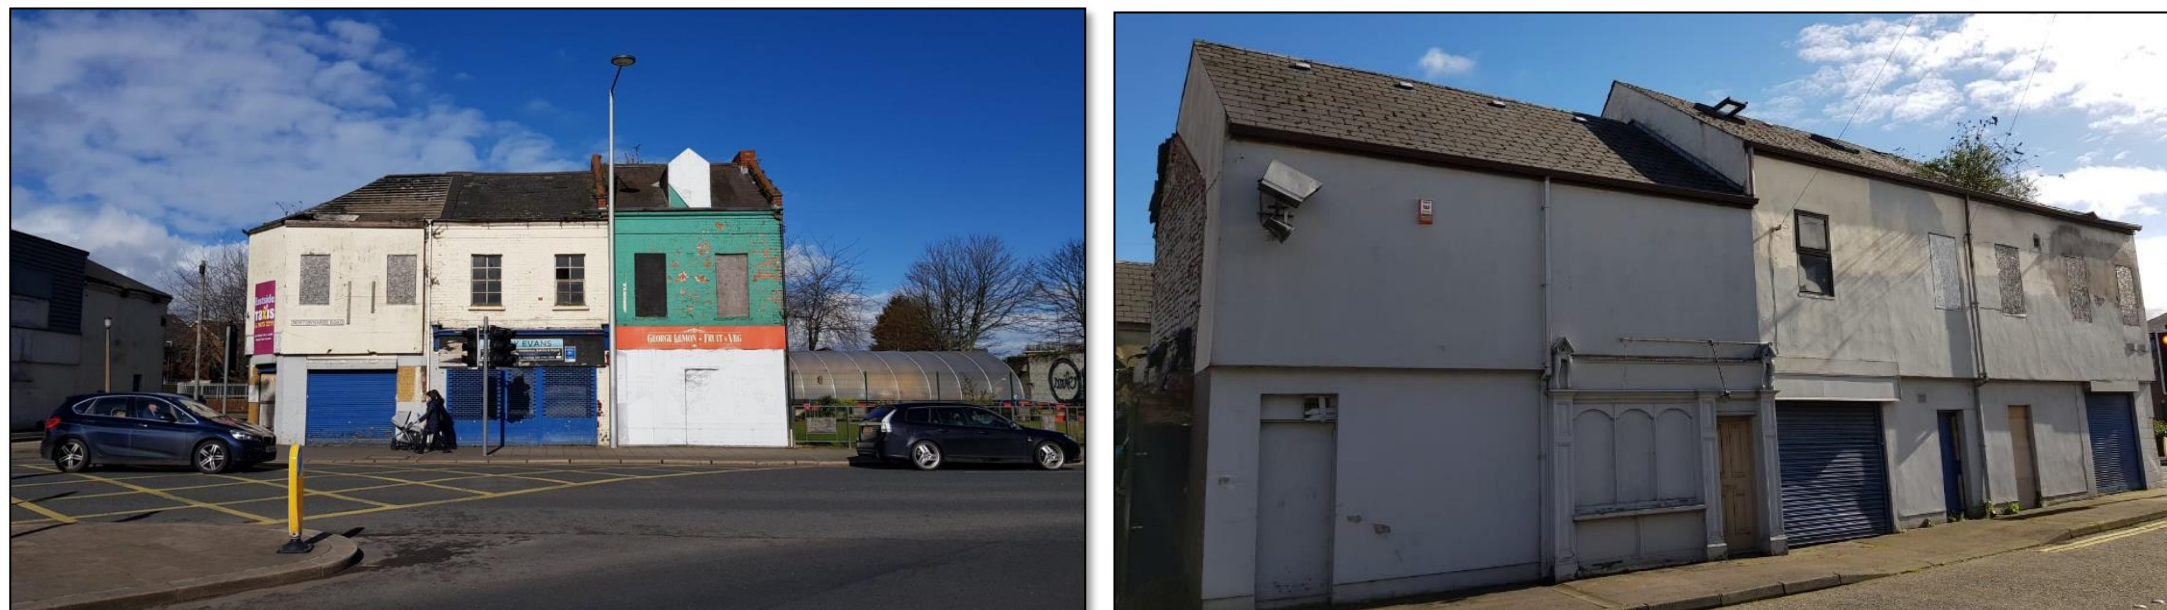
Figure 8 - Current photos showing some remedial work carried out since the fire

Some remedial work has taken place on the building - the upper floor windows have been boarded up and the façade has been cleaned. Visually, the walls look structurally sound, but the roof has been damaged beyond repair. The upper floor windows are mostly missing and there's no external windows/doors behind the shutters on the ground floor. The ground floor is in average condition but with the damaged roof the upper floor will have extensive damp, mould, and water damage.

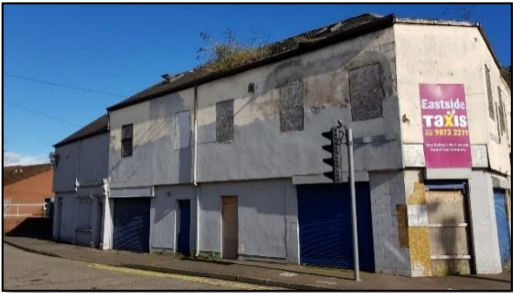
Many areas of “boast” or cracked render. Could indicate a more serious structural impairment. Tiles around entrance falling off. Remove render. Brick underneath to be inspected, cleaned and repointed if possible.	2
Existing External Brickwork

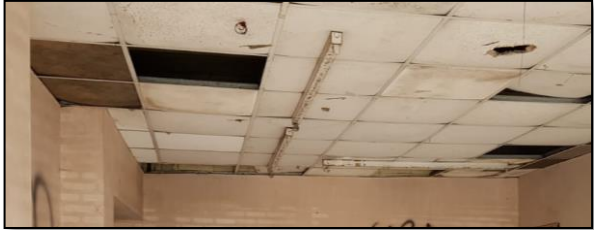
Existing suspended ceiling is rotten and falling apart. Entire ceiling to be taken down and removed.	2
Ground Floor Doors/Joinery

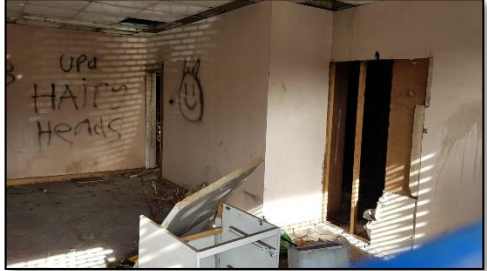
Ground floor doors/joinery work in poor condition/missing. Joinery works to be removed. New doors, skirting/architrave to be included in proposals.	2
<i>THE OBSERVATIONS BELOW ARE AREAS UNABLE TO BE INSPECTED DUE TO ACCESS RESTRICTIONS. ASSUMPTIONS HAVE BEEN MADE WHERE POSSIBLE BASED ON THE EXTERNAL CONDITION</i>				
Foundations

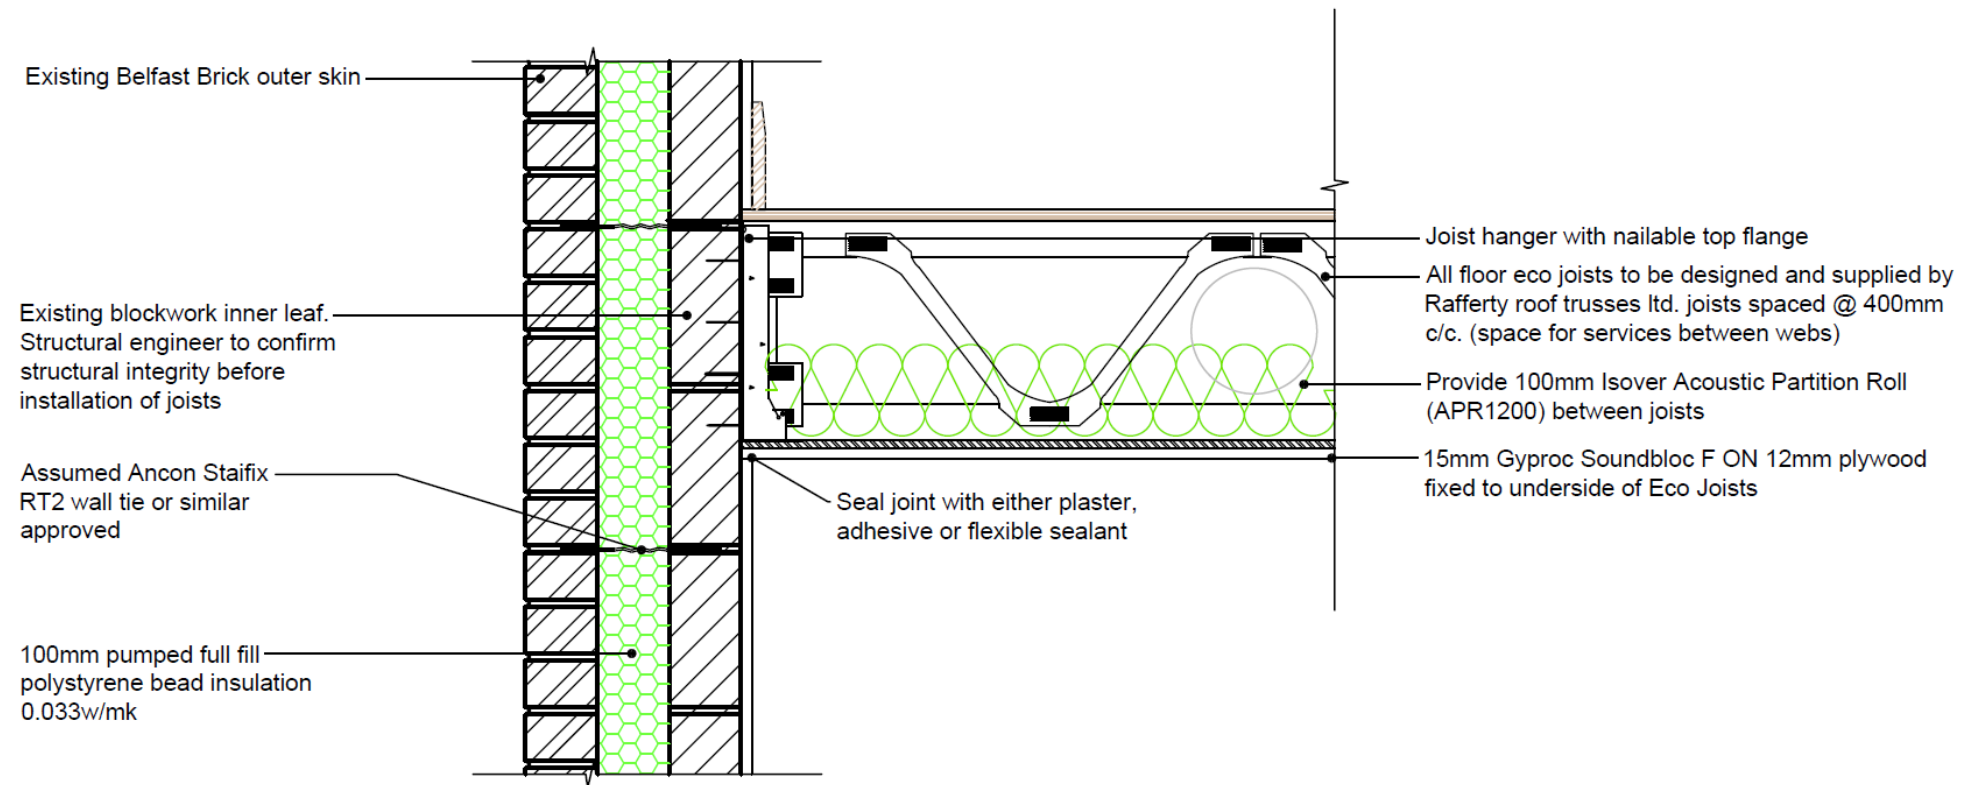
**Intermediate Floor Detail
(Eco-Joist) 1:10**

The building requires a new intermediate floor. This is difficult in a restoration with the uncertainty of conditions. A lightweight option would be advisable. With the nature of the proposed use, minimal sound penetration and large spans would be desirable.

Metal Web Joists are an ideal solution. They are lightweight, easily erected with minimal disruption to the surrounding structure. They are an engineered product, can be made to size and with the windows being removed on this building they will be easily manoeuvred into place. They come in many different sizes/designs and can be top/bottom hung. The increased strength makes them suitable for the larger span across an open retail unit and they are not susceptible to shrinkage, creaking or vibration reducing sound penetration. Services are easier to install with no cutting required. They are slightly more expensive than a standard joist. However, costs saved on labour/fixings/services and strapping makes them an extremely cost-effective option.

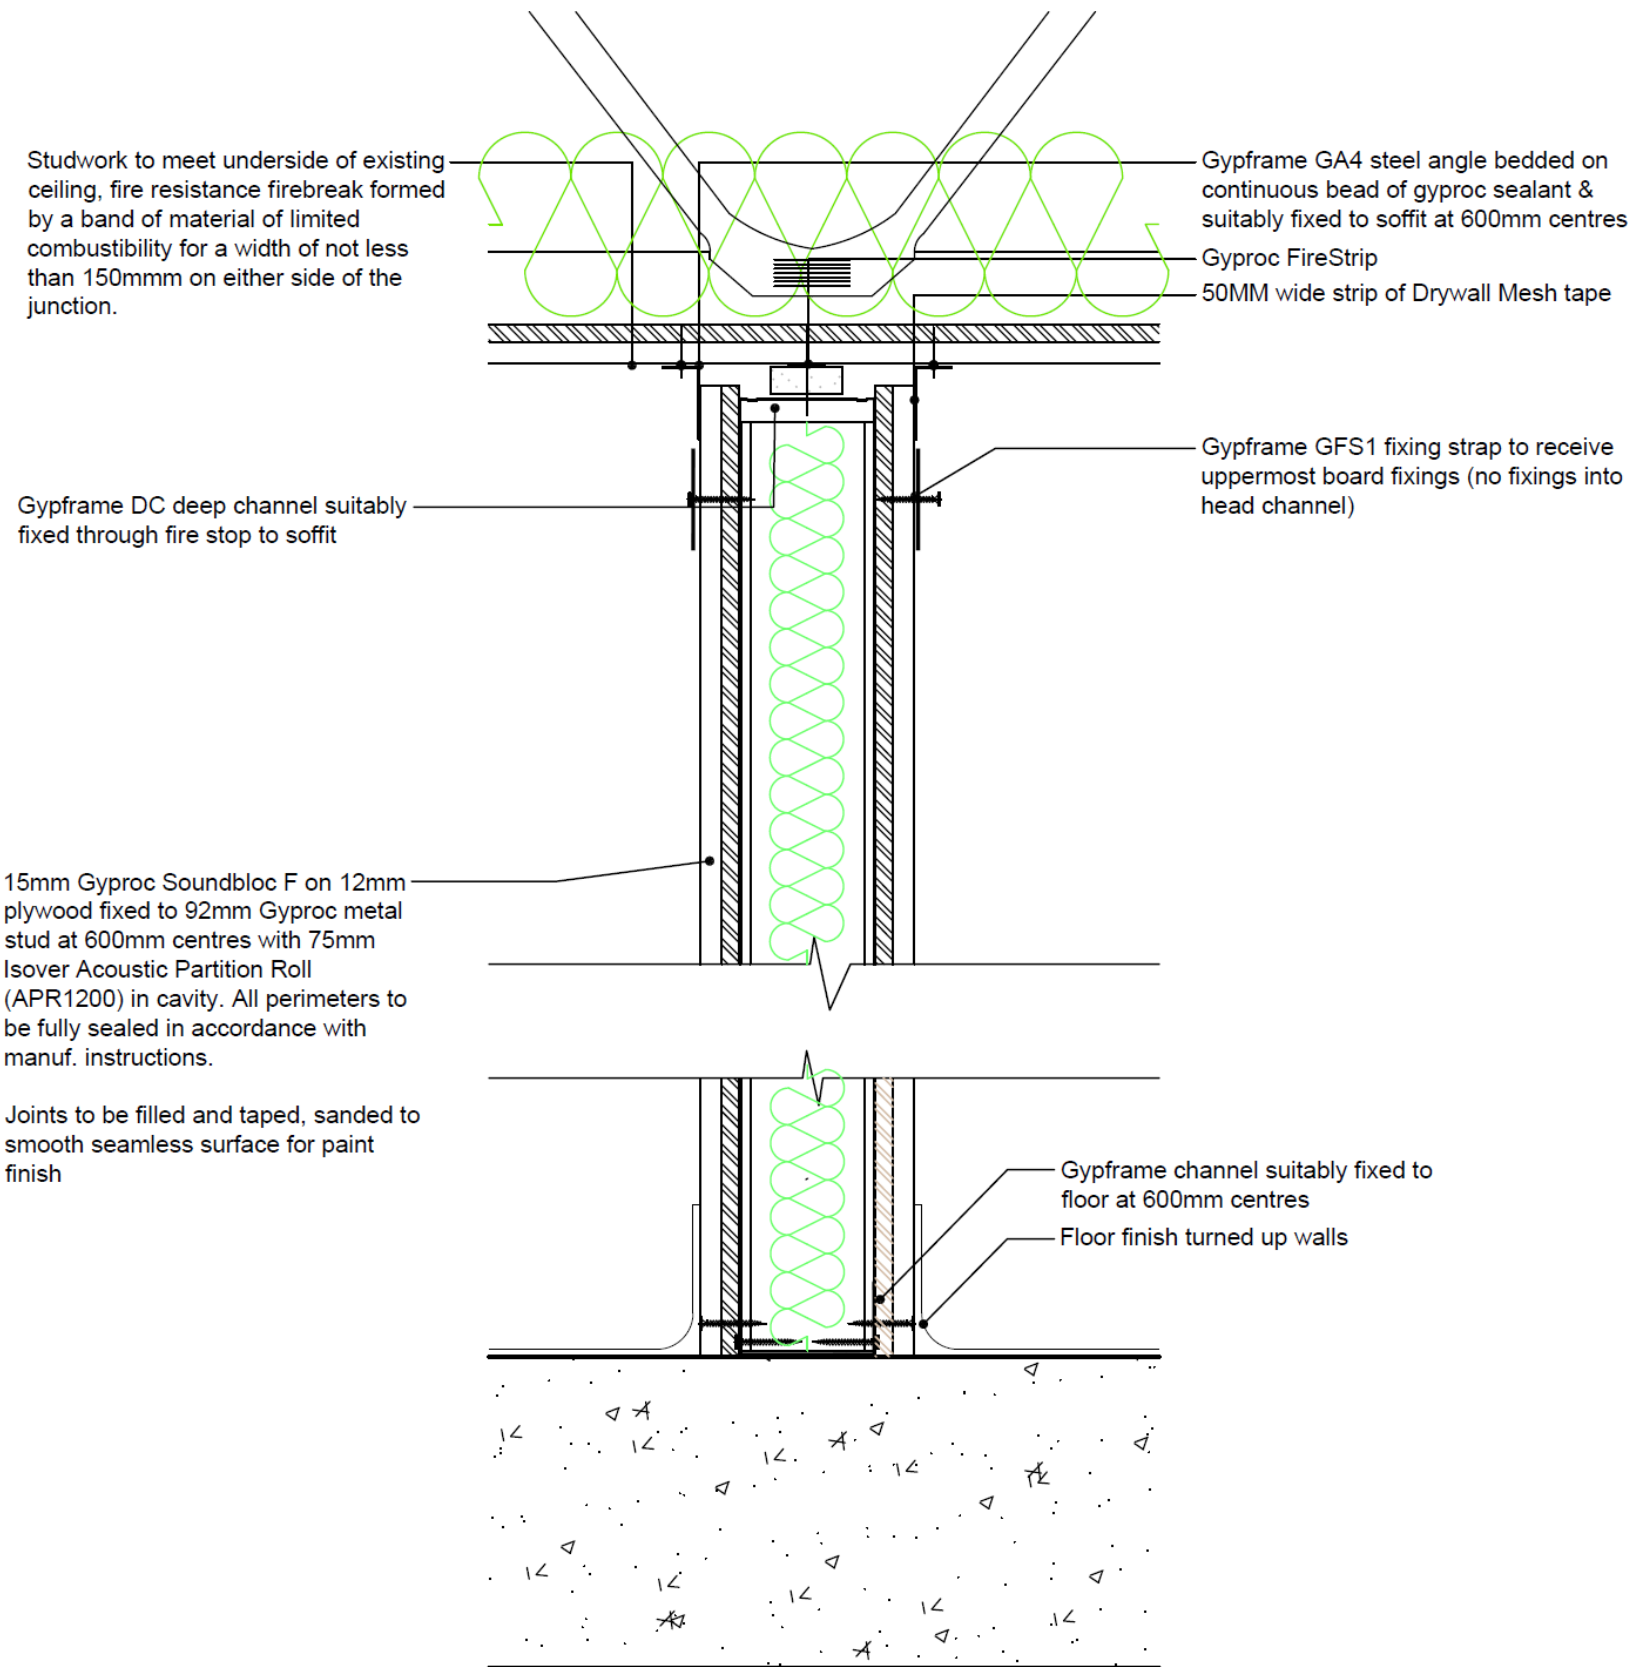
Partition Wall Details
1:5

This building requires sound and fire separation between compartments. Each fire-resistant component must have firestopping to seal opening/joints and prevent fire from passing between compartments. The insulation in the partition walls, plasterboard, fire stopping and the type of fixings require specification.

British Gypsum and Isover do several products that satisfy both the fire and sound requirements. Studwork to be Gyproc Metal Studwork at 600mm centres. Insulation to be Isover Acoustic Partition Roll (ARR1200). It is a glass mineral wool roll which provides a high level of acoustic insulation. The rolls push-fit between 600mm stud centres making it easy to install with the metal stud. Plasterboard to be Gyproc SoundBloc F. This Gypsum plasterboard has a dual performance higher density noise insulating and fire performance core protecting compartments from both sound and fire. Fire stop to be 3x25mm Gyproc FireStrip. This system gives a total of 60mins fire resistance.
